**ADDENDUM ENVIRONMENTAL IMPACT ASSESSMENT REPORT  
VOLUME 3: APPENDICES**

**RIVERINE COMMUNITY PARK**

### Underwater Archaeological Impact Assessment Memorandum

**ADCO Memorandum (DRAFT)  
Summary Statement  
22D0020, 22R0081  
UAIA River Foyle  
Lifford, Co. Donegal  
and Strabane, Co. Tyrone**

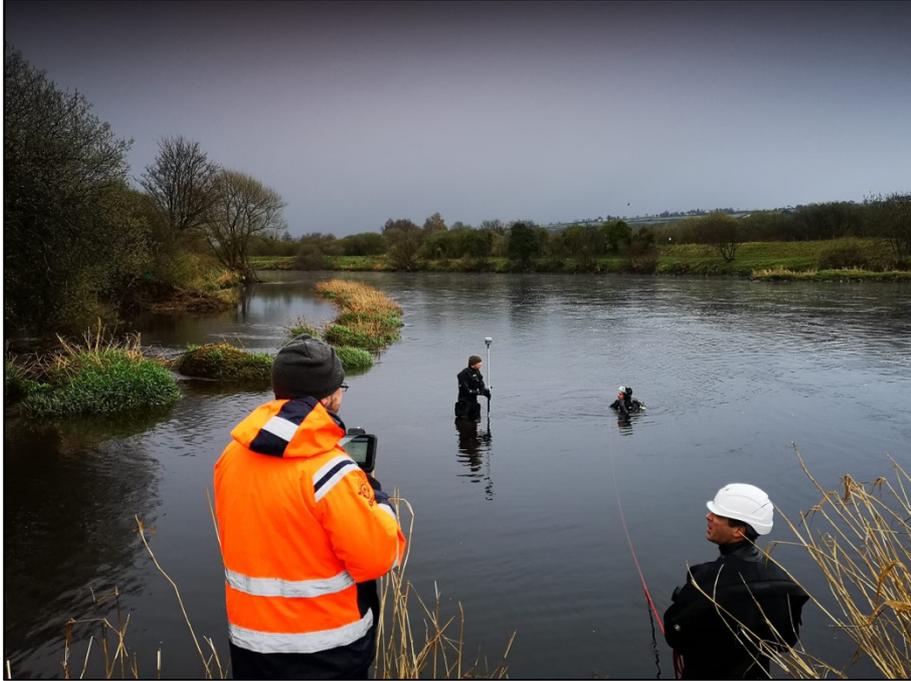
**Plate 1:** Working shot of survey at location of proposed slipway on northwest side of the River Foyle.

A systematic visual survey of the assessment area was carried out over two (2) Low Water Tide cycles, extending beyond the boundary identified for the proposed development (Plate 1). The onsite work included an intertidal/bankside walkover, waded/snorkel survey (where water depth was <500mm), and dive survey of the sub-tidal areas (where water depth was >500mm).

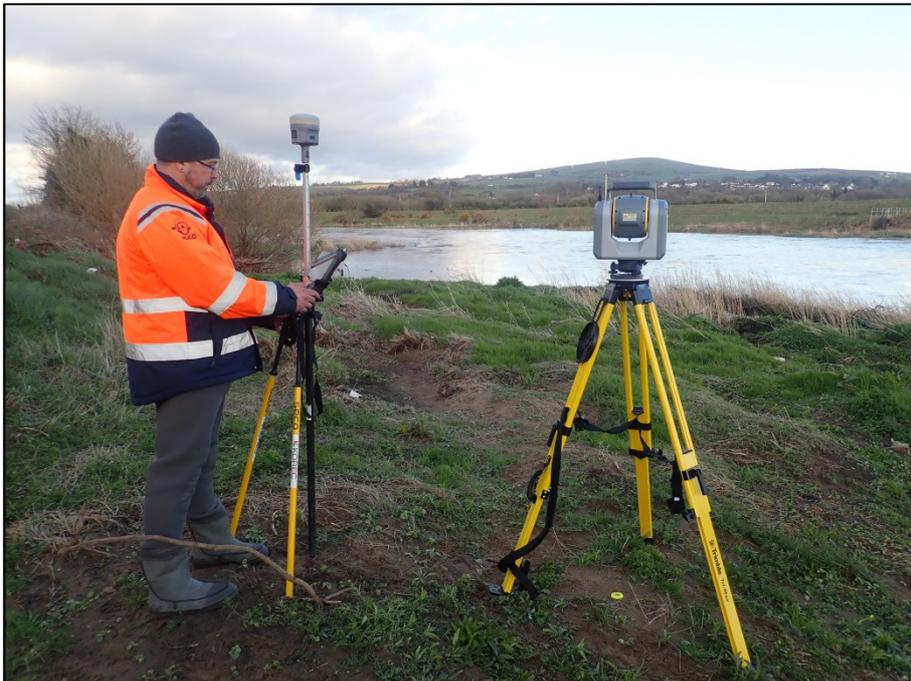
**Plate 2:** Working shot of DGPS/Total Station set-up.

Existing riverine topography was recorded (bed/bank profiles), along with any in-water features of interest that were encountered. A combination of DGPS and Total Station recording facilitated this work (Plate 2).

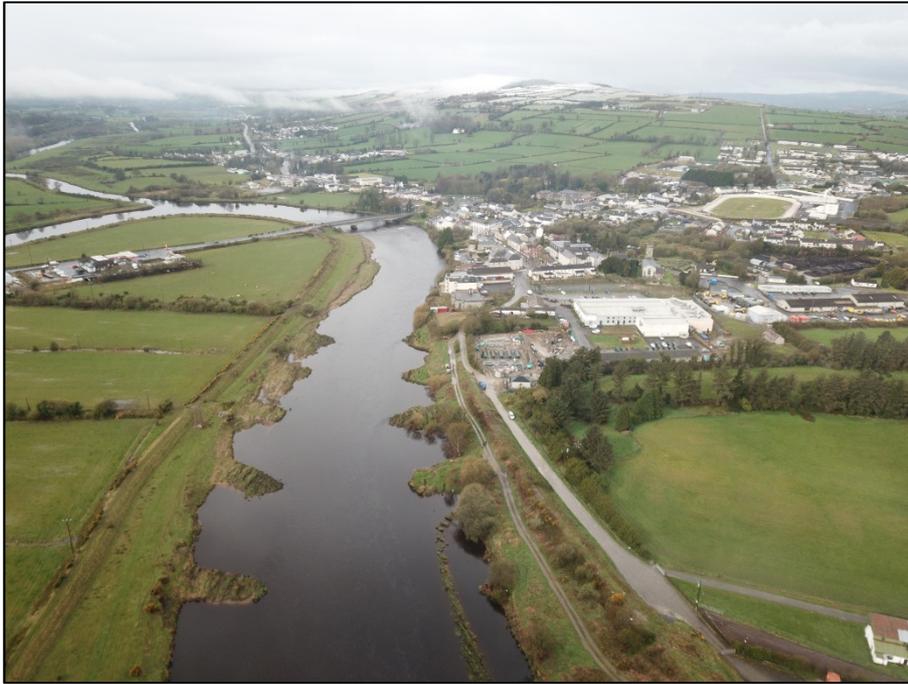
**Plate 3:** Aerial Image of river assessment area captured using ADCO Drone.

In addition, a drone was deployed to capture aerial images of the assessment area and a sonar device was used to capture acoustic images of the sub-tidal riverbed (Plate 3).

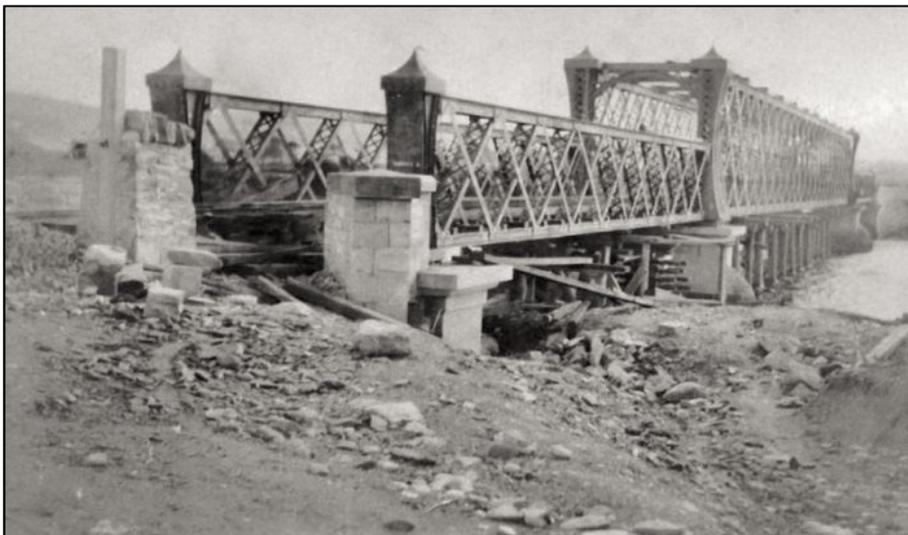
**Plate 4:** Historic photograph showing the construction of the Lifford Railway Bridge in c. 1909 (source: <http://www.sepiatown.com/814657-Strabane-Railway-Station>).

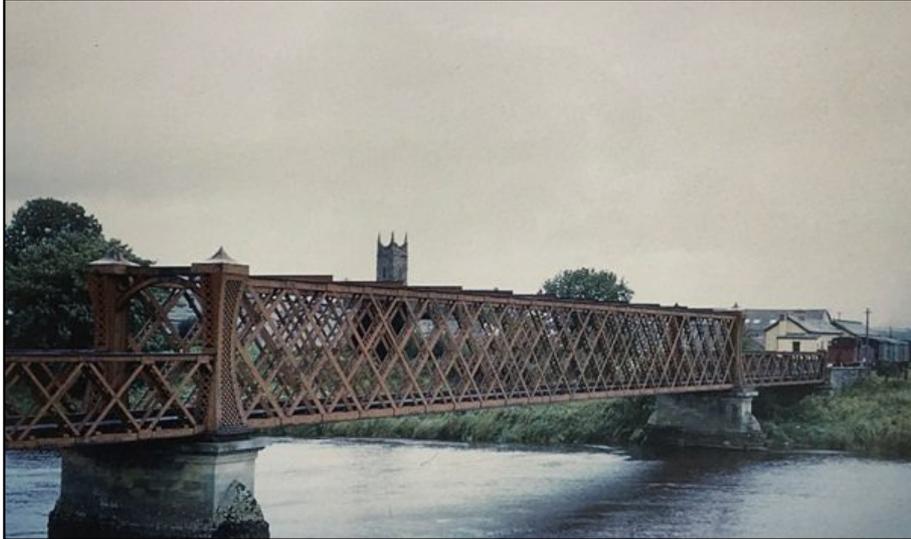
**Plate 5:** Photograph of Lifford Railway Bridge (southwest view), thought to have been taken sometime in the 1940s (source: <https://rogerfarnworth.com/2020/07/27/co-donegal-railways-ireland-part-4-strabane-to-letterkenny-part-a-strabane-to-raphoe/>).

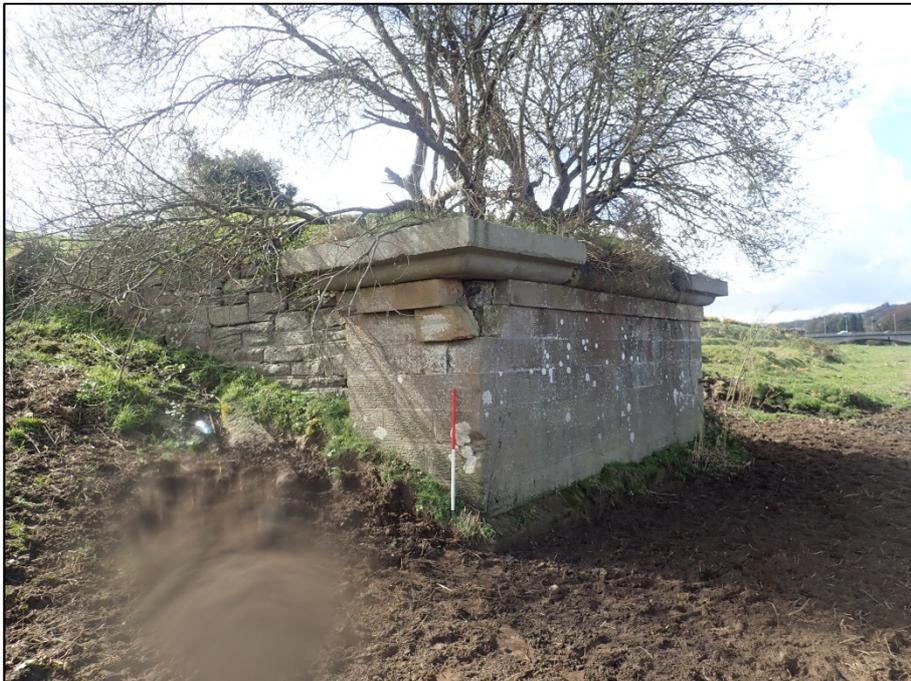
**Plate 6:** South-facing view of the remains of the masonry railway abutment located on northeast side of the River Foyle (1m scale).

In addition, the OS Third Edition map depicts the presence of a narrow-gauge railway line (Strabane to Letterkenny Railway Line) crossing the river at a point 285m downstream of Lifford Bridge, on the upstream side of the assessment area. This crossing point was constructed in the early twentieth-century (c. 1909) and comprised a latticed wrought-iron superstructure, supported upon two (2) bridge abutments and a single in-water pier, located towards the channel centre (Plates 4-5). The bridge superstructure and pier was removed in the mid-twentieth century, however, the two abutments still remain *in situ* (Plate 6). It is also likely that the two (2) levies that bound either side the waterway represent contemporary features to that of the aforementioned railway-line.

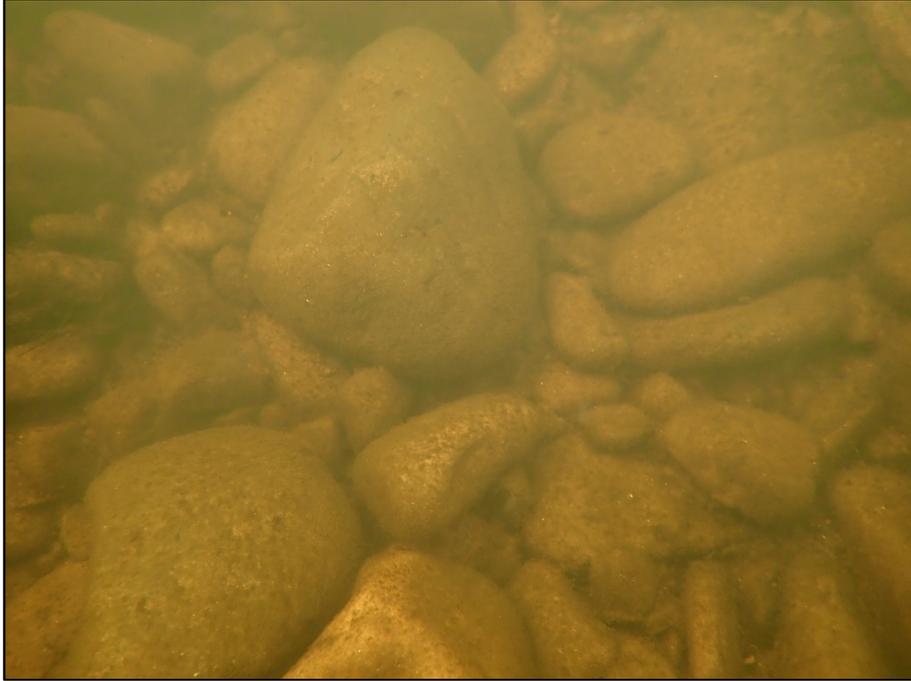
**Plate 7:** Example underwater shot showing composition of the natural riverbed present across much of the sub-tidal area of the River Foyle.

Much of the riverbed is composed of rounded to sub-rounded pebbles (<30mm) and cobbles (<200mm), interspersed with deposits of gravel and silty-sand, overlying a silty-clay substratum (Plate 7). Occasional boulders (<400mm) are also present. In addition, deeper deposits of silty-sand are also (300m+) present, where sediment deposition is taking place at locations along the northwest and southeast sides of the river. Deposition is most notable within the inlets formed between the four (4) shingle protrusions (fishing-stands), where a back-eddy is active. Leaf-litter and tree-branch debris is also frequent within riverbed matrix at these locations.

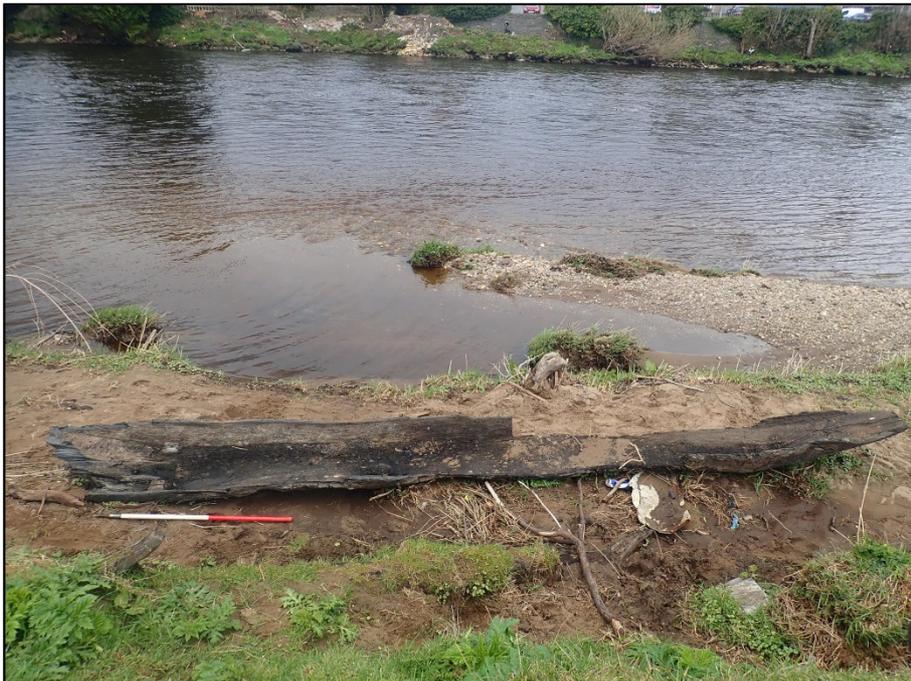
**Plate 8:** West-facing view of one of the recently discovered (March 2022) logboats located on the downstream side of Lifford Bridge (1m scale).

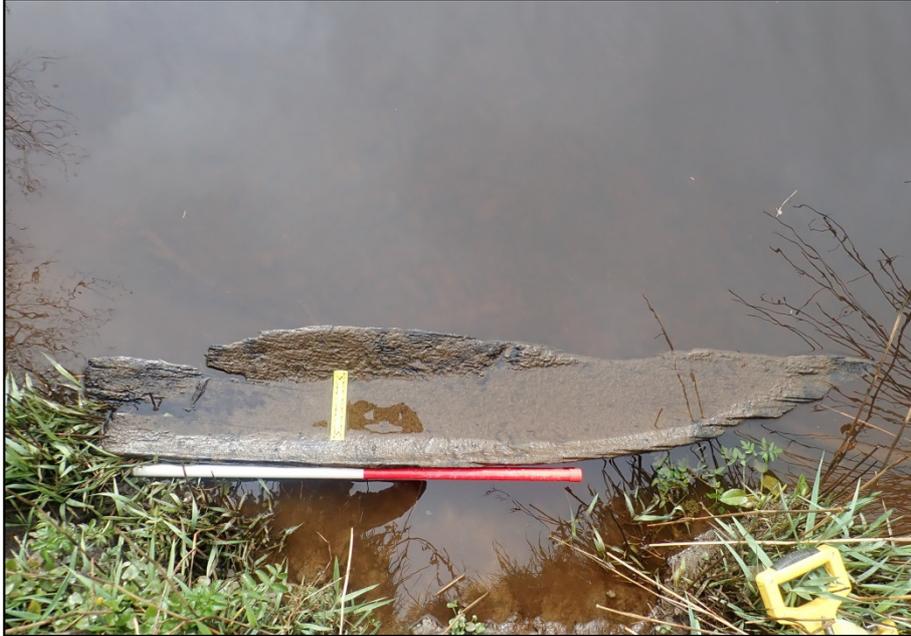
**Plate 9:** Upper (internal) surface of logboat fragment, Find Number 22D0020:01 (1m/ 250mm scales).

**Find No. 22D0020:01:** fragment of logboat, comprising a section of floor and partial side of the vessel, truncated at both ends (Plate 9); measuring 1.9m length, 310mm width, and 25mm in thickness (max.). Logboat is of oak fabric with a tight, relatively straight, grain that runs longitudinally down the line of vessel. A partially preserved sidewall rises from the floor at a c. 50° angle to a maximum height of 80mm. The internal surface of the logboat is best preserved, suggesting that the logboat may have been lying in an invert position at its source location. A series of tool marks, numbering twelve (12) in total, are visible across the internal surface (Plate 10). The underside of the

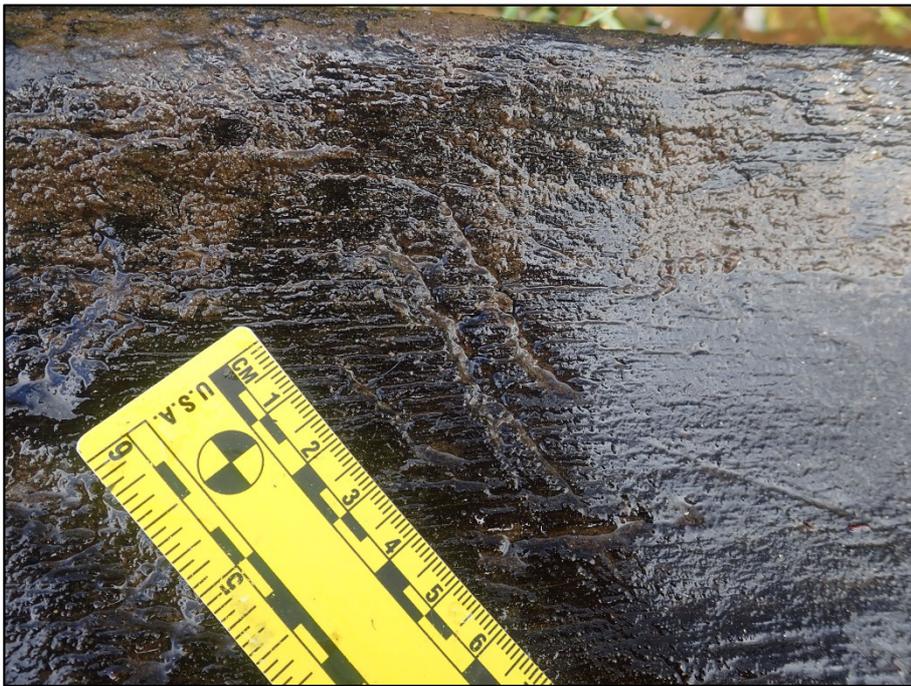
**Plate 10:** Example shot of tool (axe) marks located on internal surface of logboat.

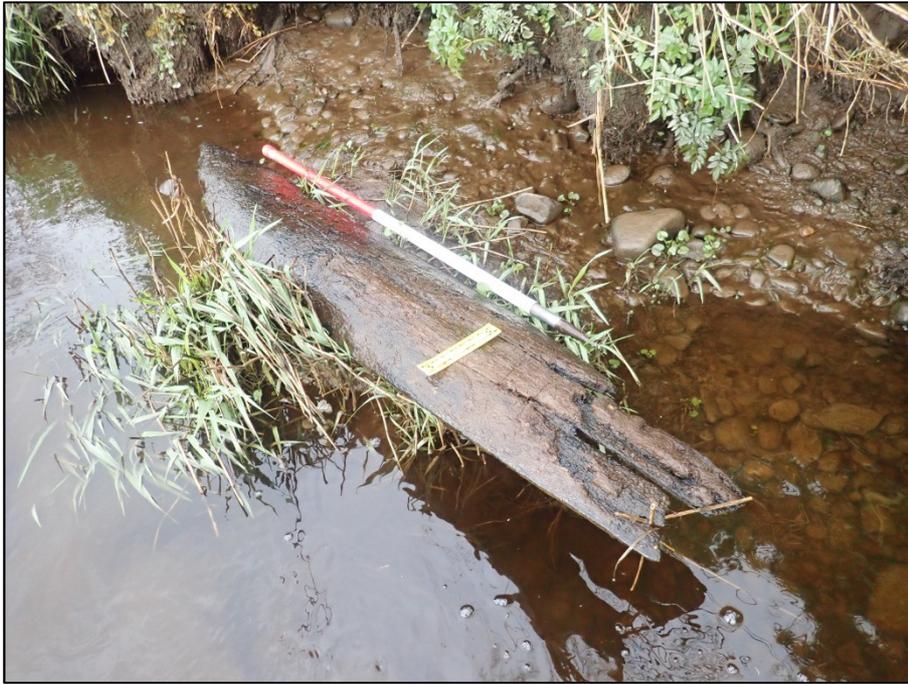
**Plate 11:** Underside of logboat fragment, Find Number 22D0020:01, showing gentle curvature to floor and presence of sapwood (1m/ 250mm scales).

vessel is eroded (water-worn), but retains a considerable amount of sapwood across its surface (Plate 11).

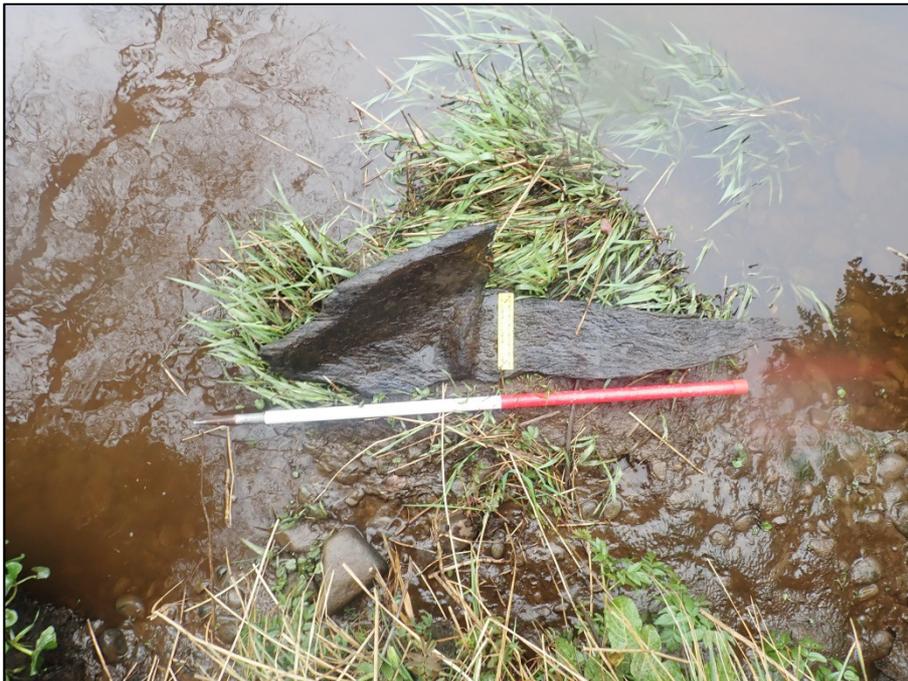
**Plate 12:** Upper (internal) surface of logboat fragment, Find Number 22D0020:02 (1m/ 250mm scales).

**Find No. 22D0020:02:** bow-end fragment from a logboat measuring 1.06m length, 350mm width (max.), and 32mm in thickness (Plates 12-13). The fragment comprises a short section of floor and part of the starboard side of the vessel, as it rises towards the bow (c. 70° angle). The logboat is of oak fabric with a tight grain. The grain radiates from the starboard side of the bow area, before straightening to run longitudinally with the line of the vessel; indicating that they may have been a knot in the wood at this location. The partial remains of a rib-like feature is also present (towards the bow) and is likely to have served the dual function of (a) transverse strengthening of the bow and (b) a foot-brace position when paddling (Plate 14). This structural feature survives to a length of 120mm, measuring 55mm width (max.) and 200mm in height.

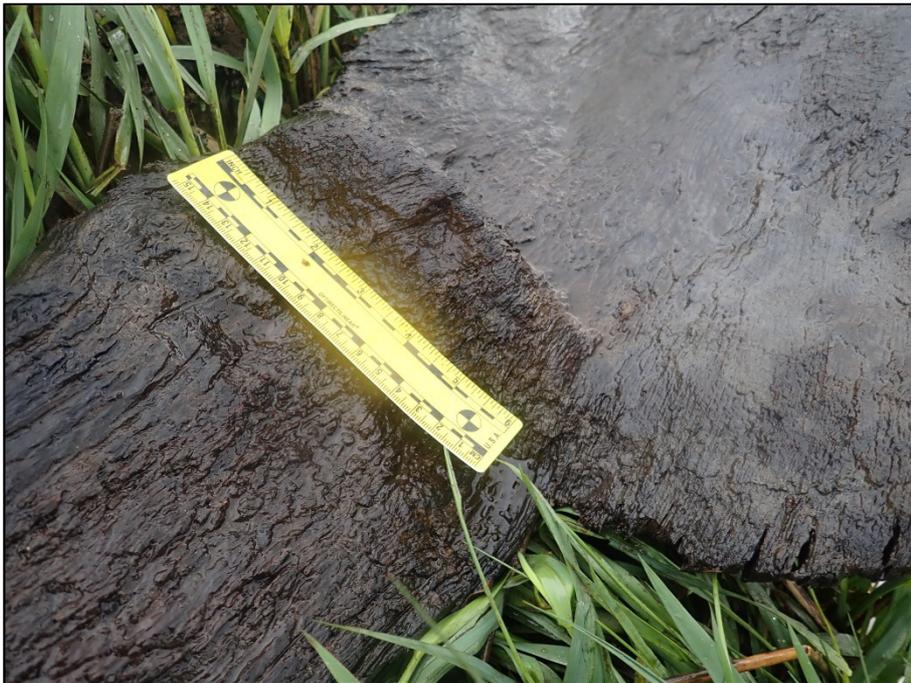
**Plate 14:** Detail shot of partial remain of possible foot-brace/ transverse strengthening rib located towards bow end of vessel (250mm scale).

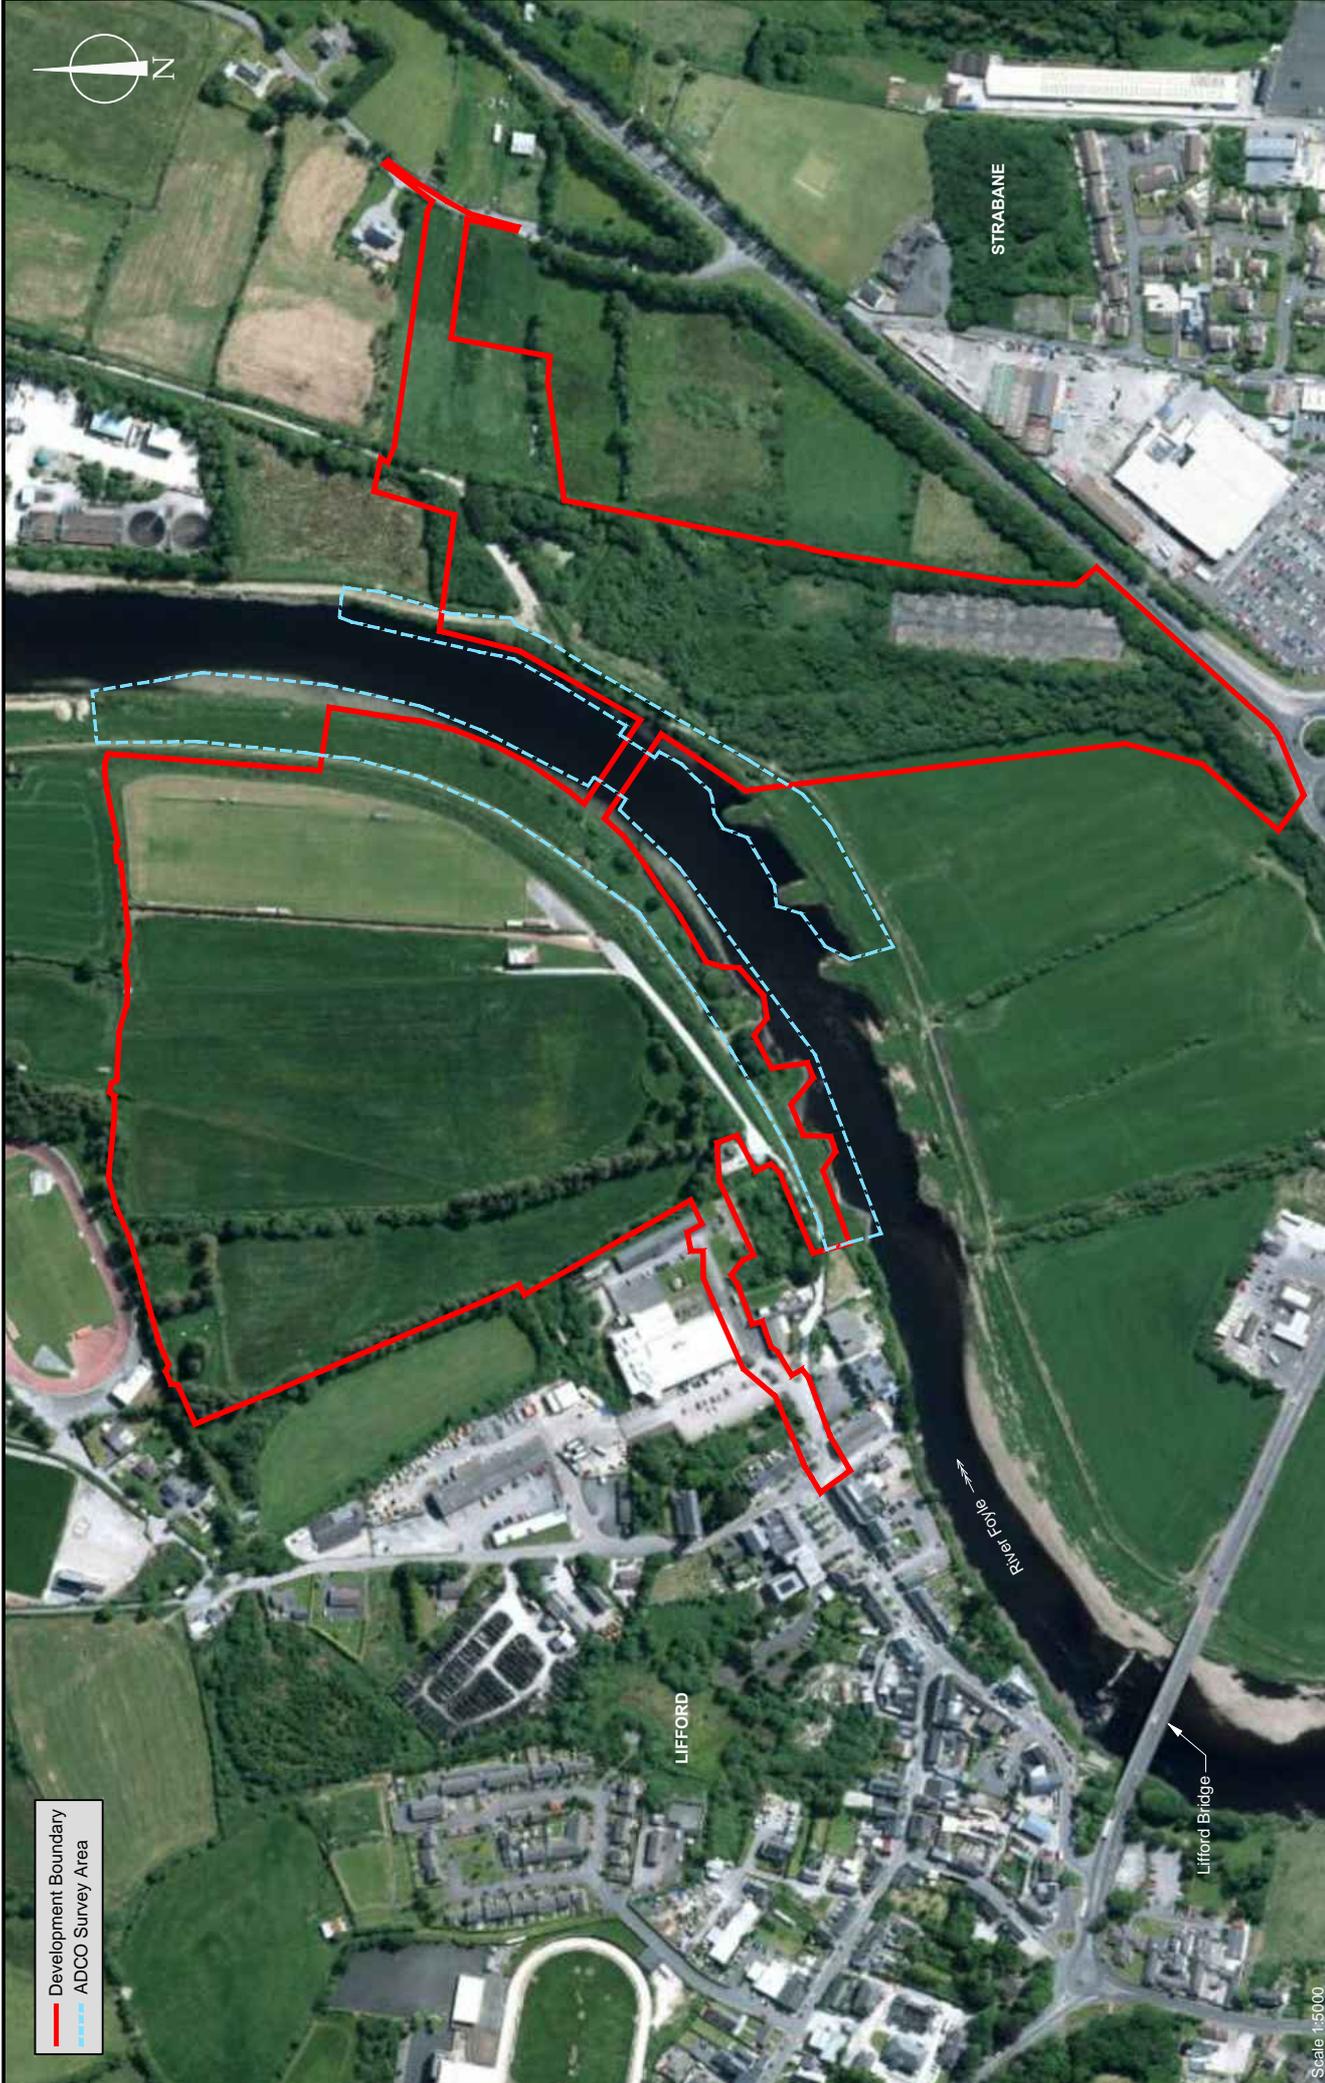
Development Boundary  
 ADCO Survey Area

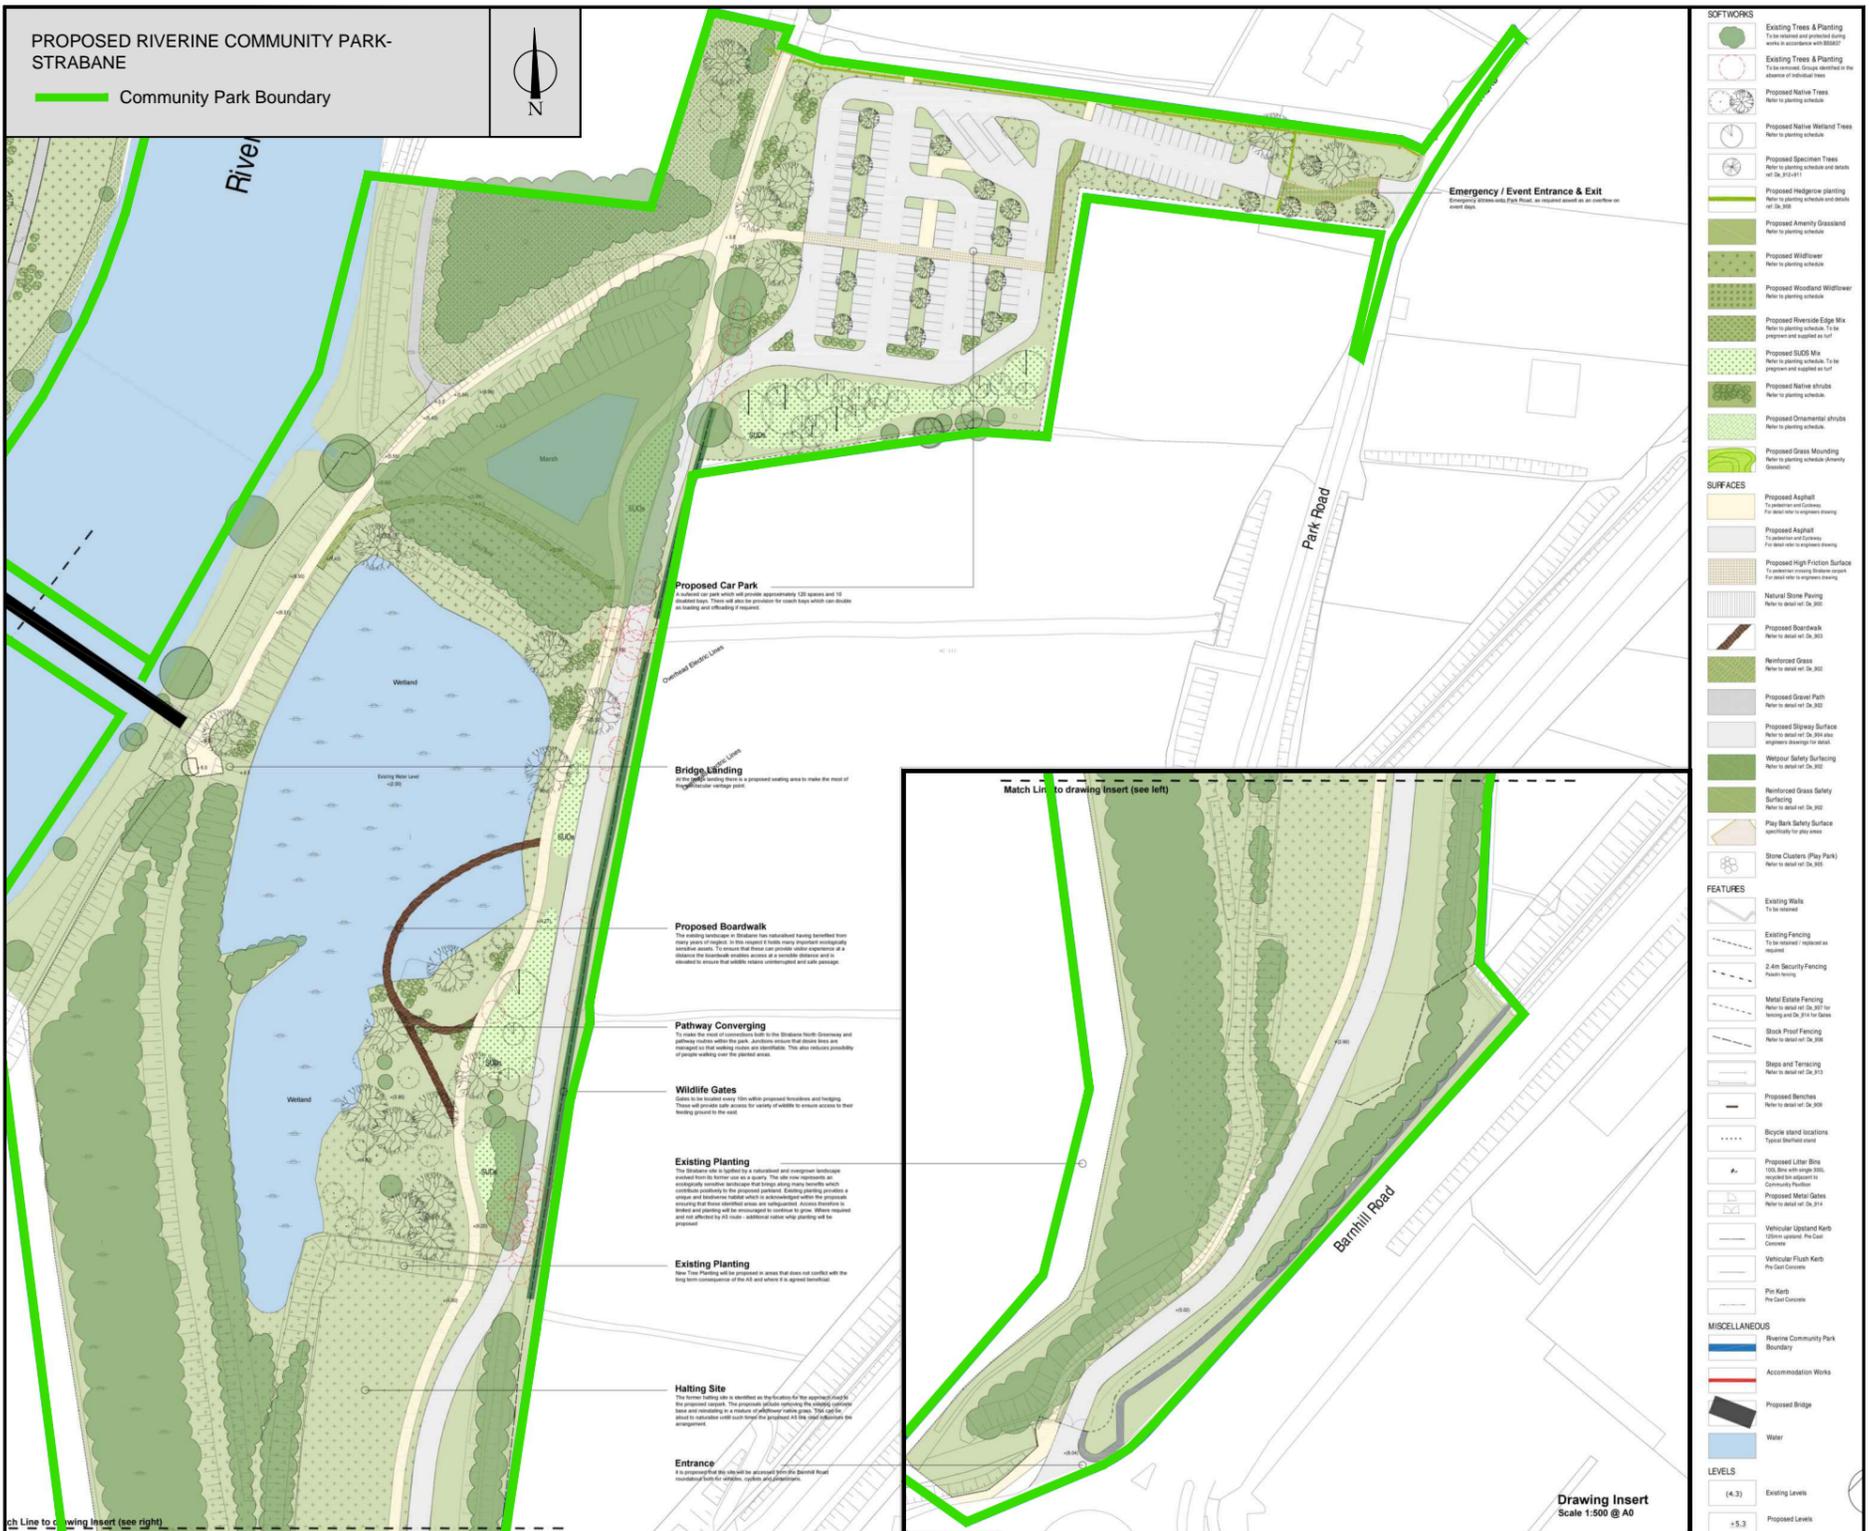
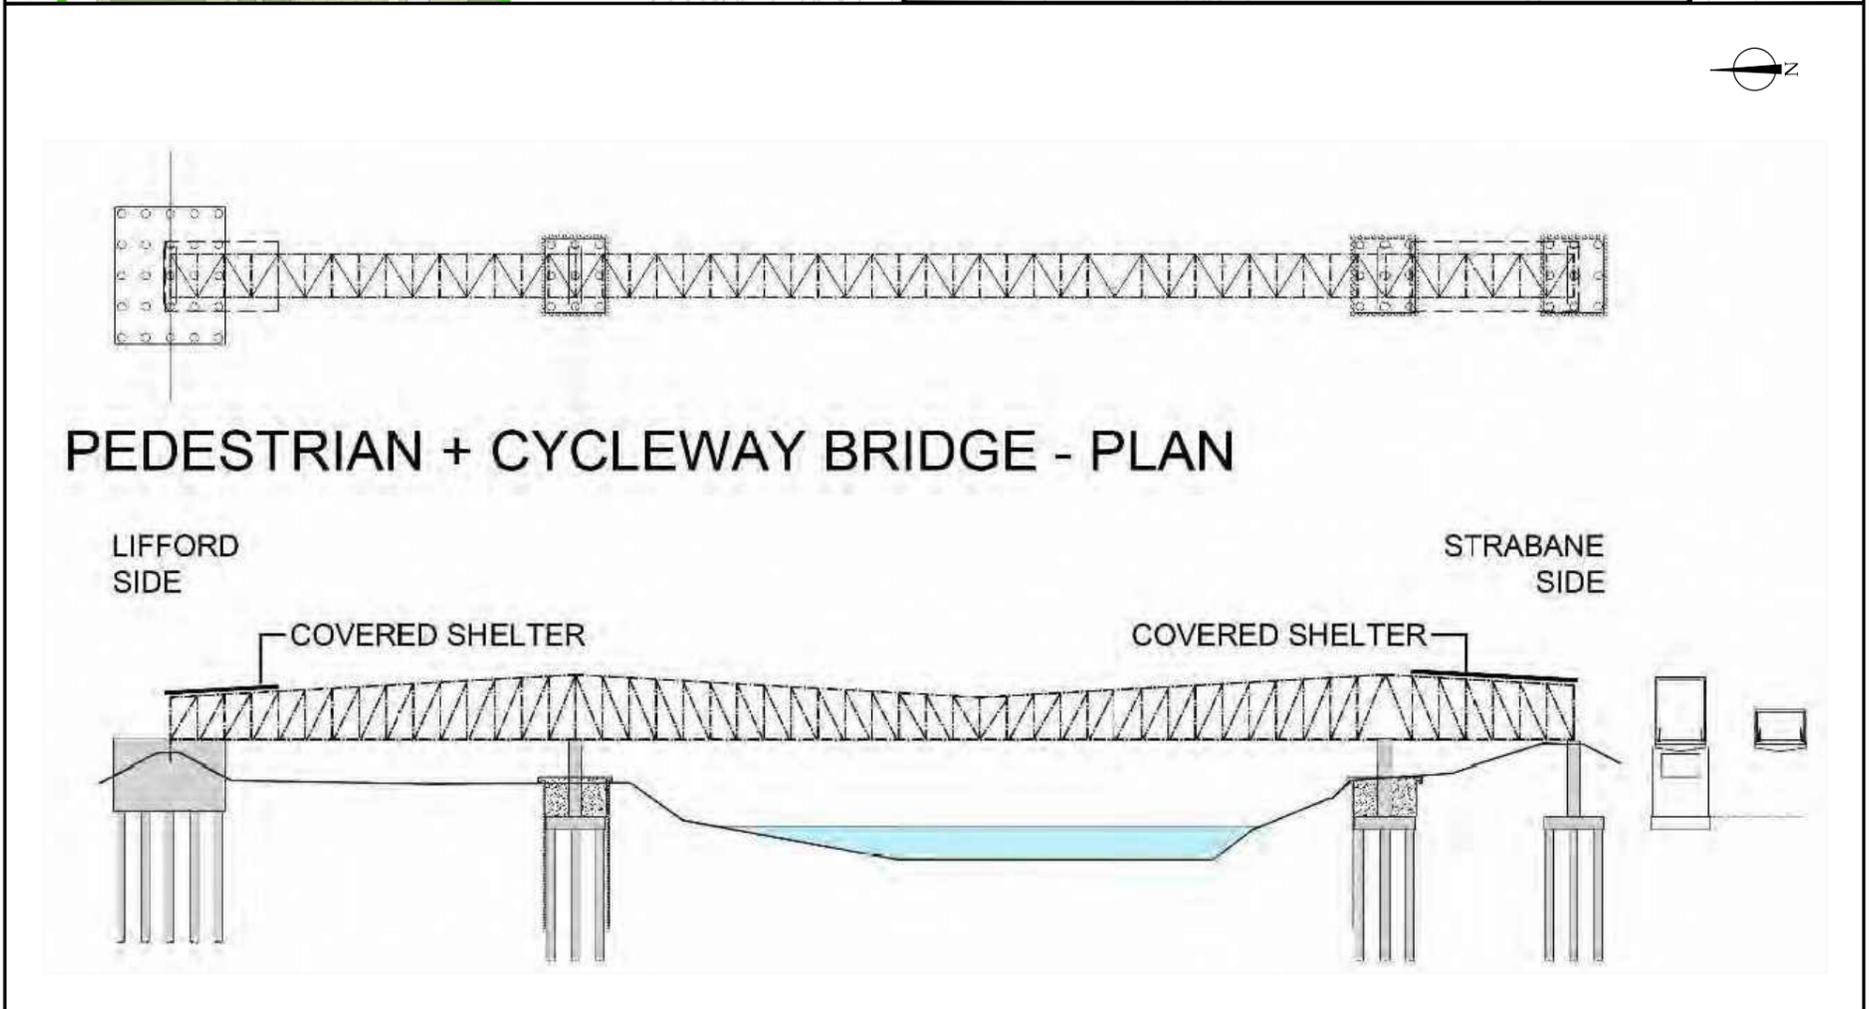
<b>Notes</b> Source: Top-figure adapted from Project Drawing 1383-TPHC-Z0-XX-LA-102_P00 [The Paul Hogarth Company]. Bottom- Figure 4, extracted from of the Outline Construction Environmental Management Plan, Page 12.  [see Figure 2 for Layout Plan on Lifford side of river].	<b>A3</b>	<b>Title</b> Figure 3- [Top] Extract from Project Drawing showing proposed layout of the community park on the Strabane side of the River Foyle [Bottom] Extract from Project Drawing showing proposed pedestrian bridge linking the two sides of the park.
	<b>Client</b> McAdam/ Donegal County Council	<b>Job/Exc No.</b> 22D0020, 22R0081	<b>Compiled by</b> R. Bangarter
<b>Project</b> Riverine Community Park- UAIA, River Foyle	<b>Date</b> 12.03.22	<b>Scale</b> 1:2000/ NTS	<b>Drawing No.</b> Figure 3

ADCO recently carried out the UAIA, under licence from the DHLGH, on 7th and 8th April 2022; Licence Numbers 22D0020 and 22R0081. The assessment considered the following development items (Figures 2-3):

- Works on the foreshore including construction of a cast (*in-situ*) concrete slipway on the Lifford side of the River Foyle. The slipway is to measure c. 40m length and 5m in width; extending c. 15m across the intertidal foreshore and into the subtidal zone. The slipway will include adjoining steps (natural stone paving) and the provision of a reinforced grass path to a new timber fishing pod.

- A pedestrian/cycle bridge, linking the two sides of the proposed community park. The structure is to comprise a double-span (steel-truss) structure with an overall length of c. 115m. The larger span will extend across the river for a distance of c. 88m. The second span, measuring 27m length, will extend over land from the riverbank (Lifford side) to raised-ground beyond.

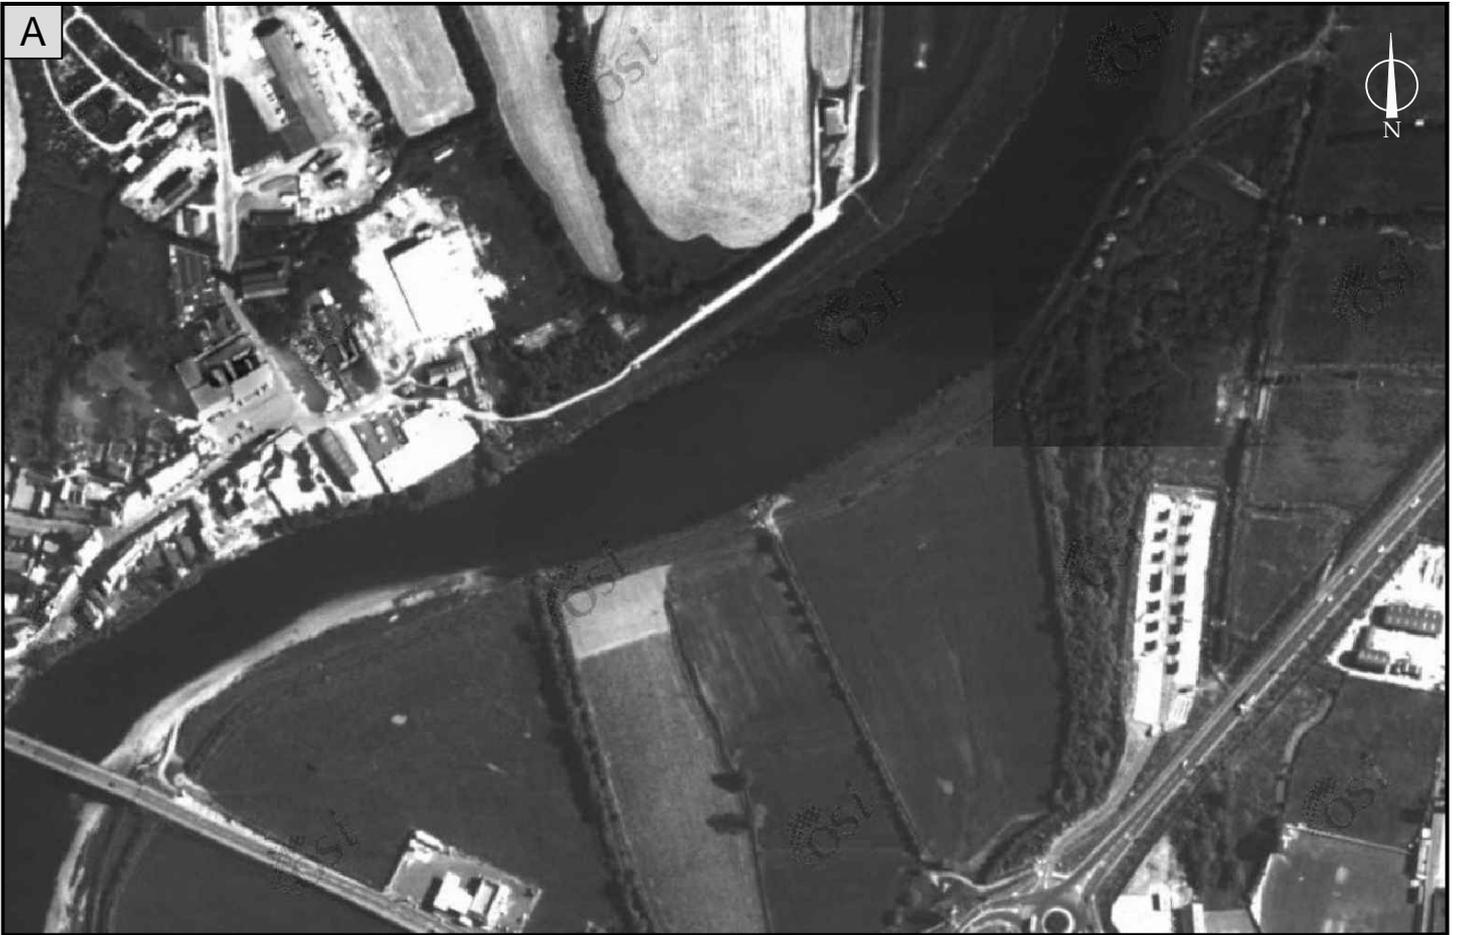
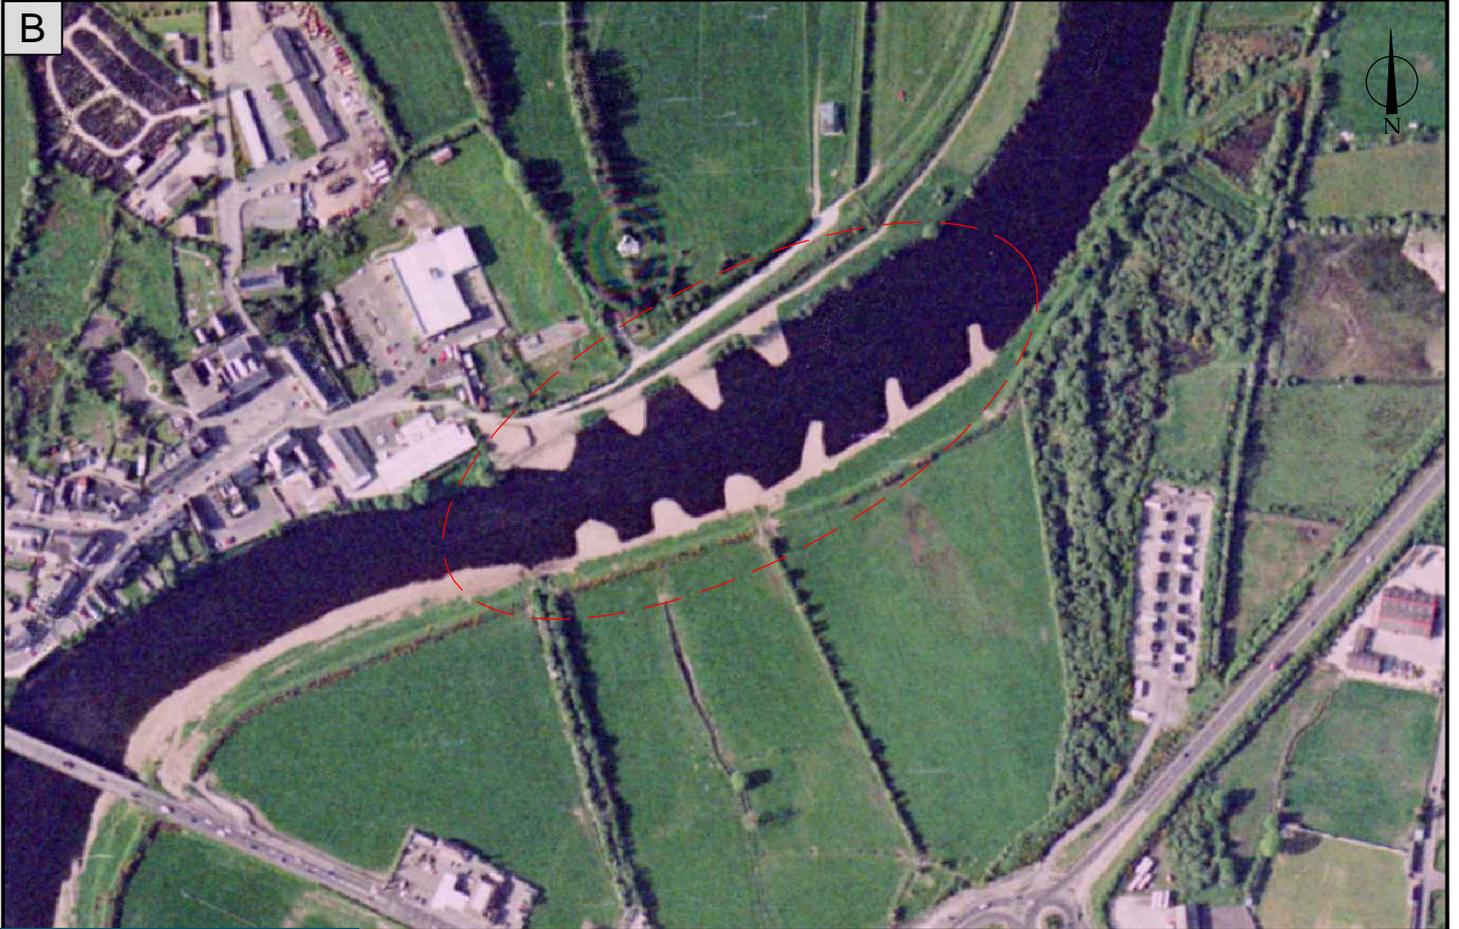
**Drawing No.**  
 Figure 5

**Title**  
 Figure 5- Comparison of Aerial Orthoimagery of River Foyle Assessment Area, captured in [A] 1995 and [B] 2000.

Other, more recent, alterations to the river channel are evident with the addition of a series of sizable, shingle-type, protrusions into the River Foyle; four (4) on the west side of the waterway and six (6) on the east. Examination of the aerial orthoimagery verifies that these features did not exist prior to 1995, instead appearing as newly established features within the aerial imagery taken in 2000 (Figure 5 A/B). These features are thought to represent river-access points for fishing (or similar).
