**ADDENDUM ENVIRONMENTAL IMPACT ASSESSMENT REPORT  
VOLUME 3: APPENDICES**

**RIVERINE COMMUNITY PARK**

### Underwater Archaeological Impact Assessment Memorandum

**ADCO Memorandum (DRAFT)  
Summary Statement  
22D0020, 22R0081  
UAIA River Foyle  
Lifford, Co. Donegal  
and Strabane, Co. Tyrone**

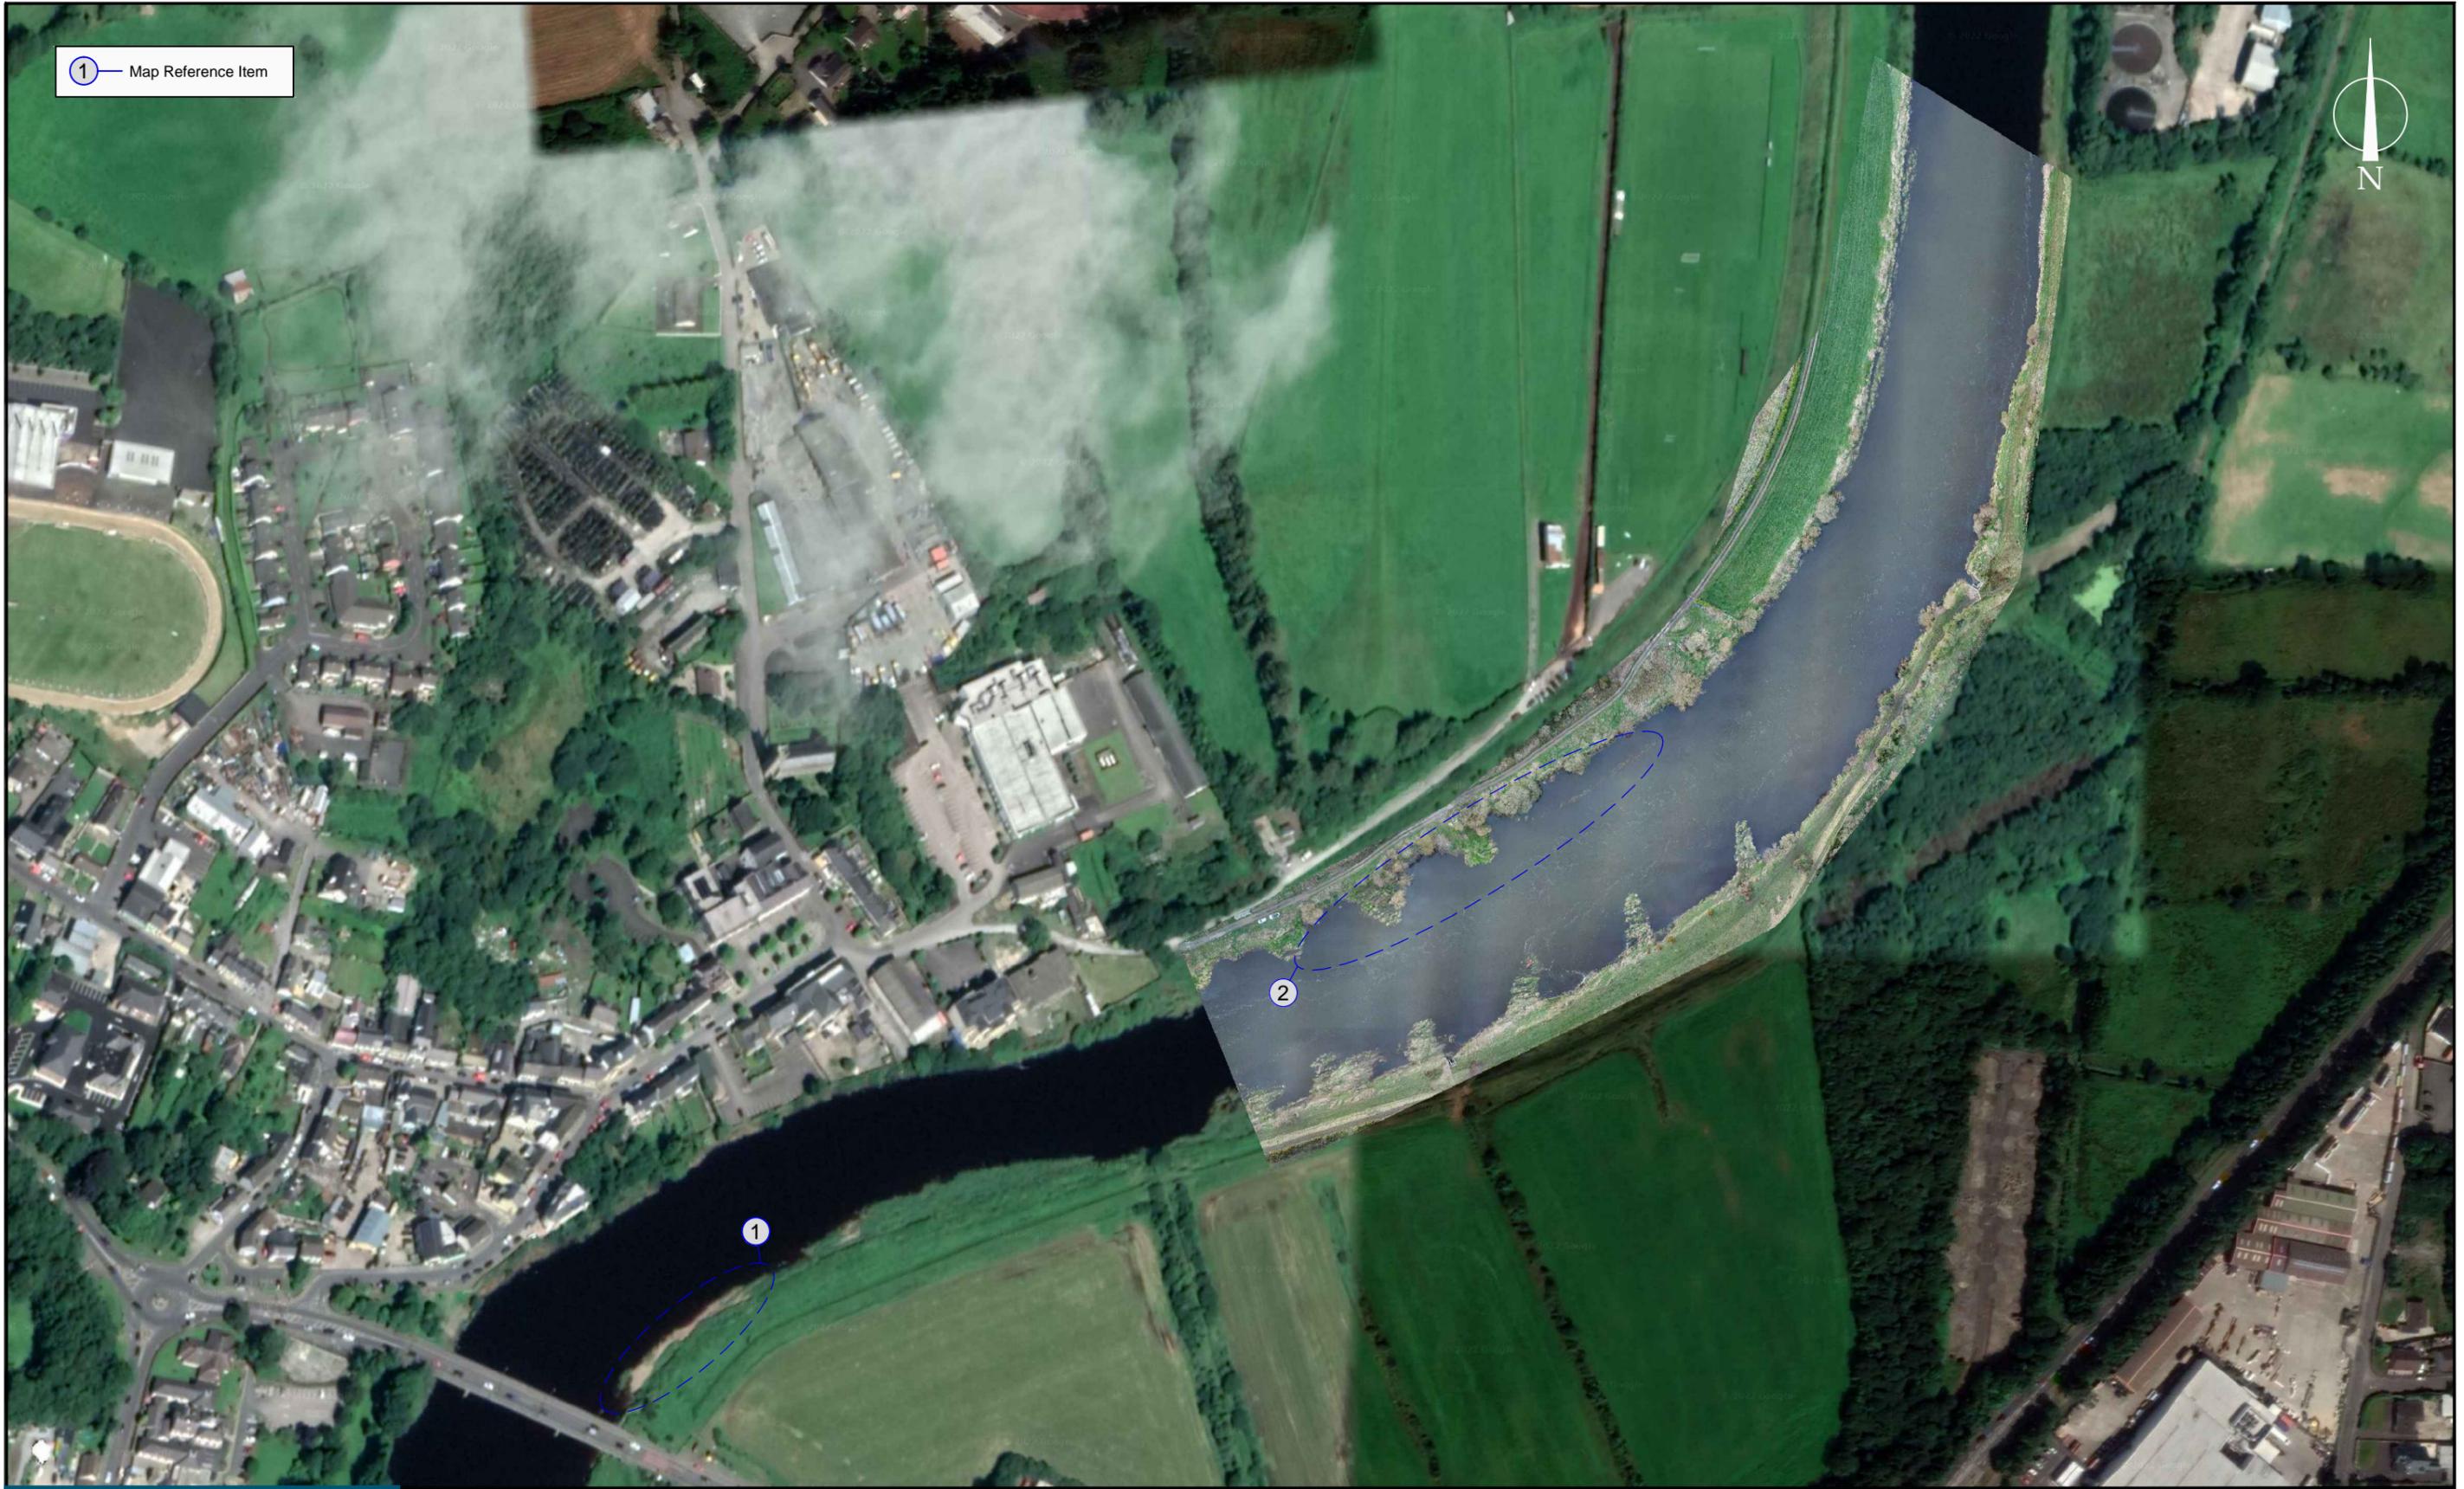
**Notes**  
 Imagery captured by ADCO (R.Bangerter/ D.Lenehan) on 7th April 2022 using an aerial drone [coordinate projection- WGS84].  
 [Drone imagery is superimposed upon Google Satellite Imagery gathered April 2021].

A3	<b>Job/Exc No.</b> 220020. 22R0081	<b>Compiled by</b> R.Bangerter	<b>CAD reference</b> RiverFoyle_RCP	<b>Client</b> McAdams/ Donegal County Council	<b>Title</b> Figure 6- Aerial (drone) Survey of Assessment Area with Map Reference Items 1-2 superimposed.
	<b>Date</b> 13.04.22	<b>Scale</b> 1:3000	<b>Drawing No.</b> Figure 6	<b>Project</b> Riverine community Park- UAIA, River Foyle

Active deposition of waterborne sediments is evident on the east side of the river at Lifford Bridge, across the inner side of a west-facing meander in the river (Figure 6; Map Item 1). This location is a proven catchment area for archaeological material, the regular discovery of re-deposited logboat finds having taken place within this area. A total of fifteen (15) such finds has been documented for this location, two (2) of which were recovered as recently as March 2022 (Plate 8). These finds are being periodically eroded from their source location (riverbed/bankside deposits), somewhere upstream of Lifford Bridge; most likely close to the confluence of the River Mourne and River Finn (c. 240m upstream).

Deposition is also observed to be active downstream, along the northwest side of the river and within the current assessment area; across the inner side of an east-facing meander at this location (Figure 6; Map Item 2). Given the propensity for logboat finds a short distance upstream, it is perhaps not surprising that the survey encountered two (2) fragments of logboat within this downstream area also.

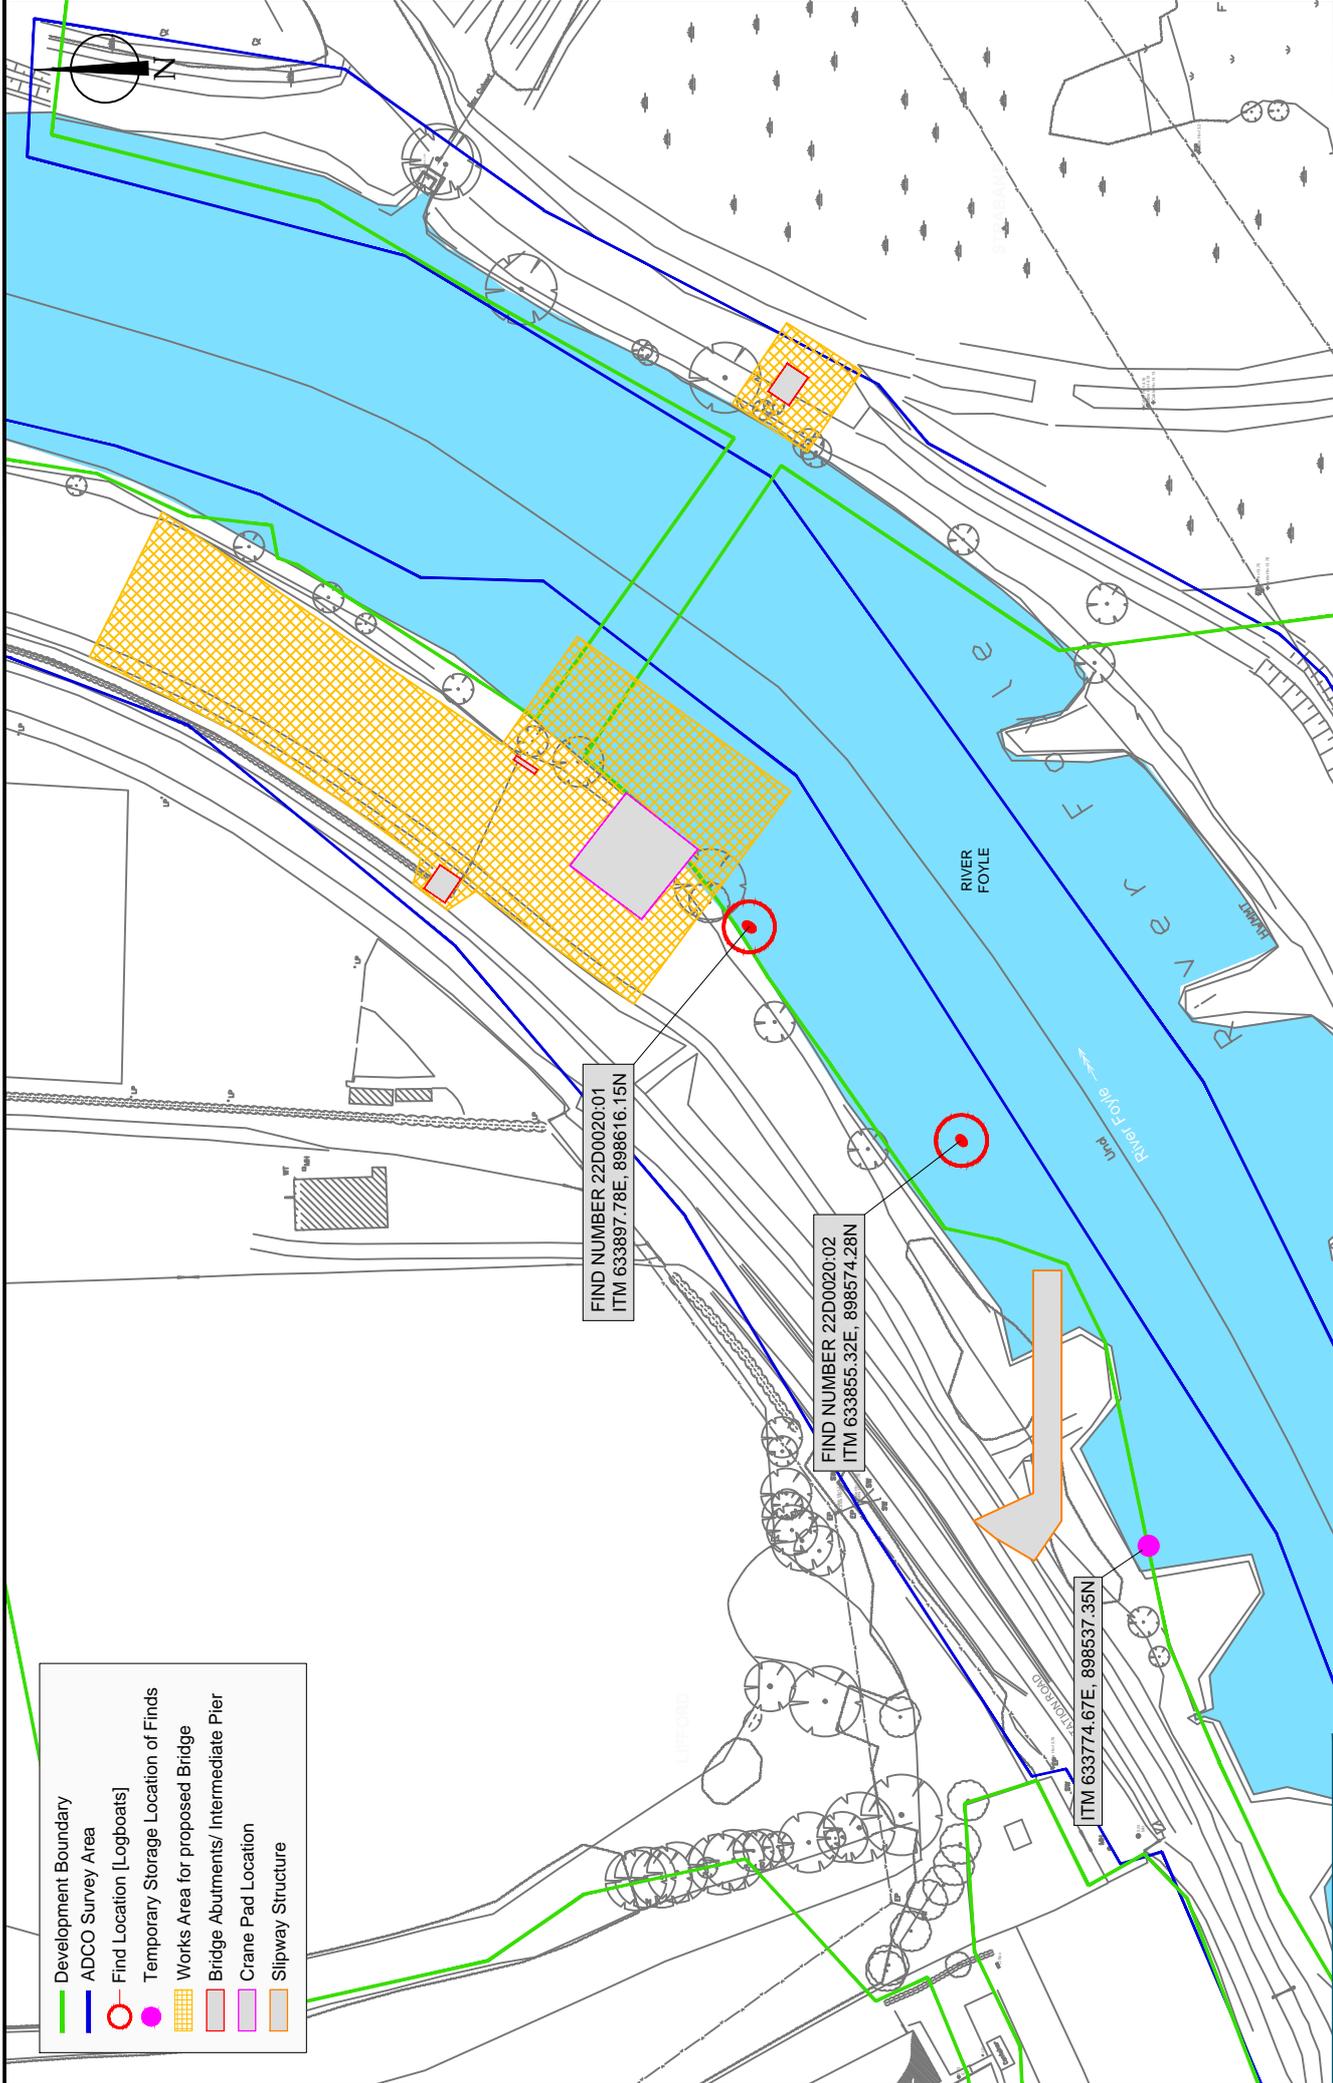
- Figure 7:** Find location of Logboat fragments, Find Numbers 22D0020:01 and 22D022:02, shown in relation to Development Boundary and ADCO Survey Area.

<b>Notes</b> Source: DGFS survey data superimposed upon OS Background Mapping		<b>Job/Exc. No.</b> 22D0022, 22R0081		<b>Complied by</b> R.Bangorier/ D.Copeland		<b>CAD reference</b> RiverFoyle_RCP		<b>Client</b> McAdam/ Donegal County Council		<b>Title</b> Figure 7- Find location of Logboat fragments, Find Numbers 22D0020:01 and 22D0020:02, shown in relation to Development Boundary and ADCO Survey Area.	
<b>Date</b> 13.04.22		<b>Date</b> 13.04.22		<b>Scale</b> 1:1500		<b>Drawing No.</b> Figure 7		<b>Project</b> Riverine Community Park- UAIA, River Foyle			
<b>A4</b>

Two (2) fragments of logboat (dug-out canoe) were discovered as part of the underwater survey (Figure 7). Both represent re-deposited items, lying on the surface of the riverbed close to the northwest side of the River Foyle; having most likely floated downstream during a recent floodwater event.

Both finds were encountered on the northwest side of the waterway, positioned in relatively close proximity to each other (Figure 2, Table 1). Find Number 22D0020:001 was located within 9m of the proposed works area associated within the pedestrian/cycle bridge, while Find Number 22D0020:002 was located at a point 58m upstream.
